Manhole Inspection Summary

Manhole # S37Y1_004MH

Insp Date: **6/12/09 10:54 AM**

Location Address: **3724 S Hanover St.**

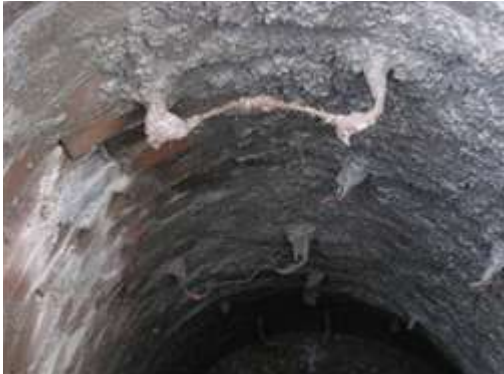
Steps Count: **6** Missing: **6** ☒ **Corroded**

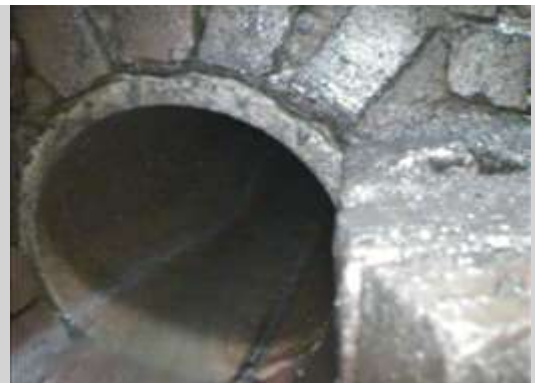
12 O'Clock Outflow

10 in. Circular Gravity Sewer
Pipe Out @ 12 O'Clock

Pipe Height: **10.8** (in.) Rod and Bar (Angled)
Pipe Material: **Unknown** ☐ Pipe Lined
Invert Depth: **11.55** (ft.) Flow Characteristics: **Slow**
Deposits: ☒ None ☐ Mud ☐ Sludge ☐ Debris ☐ Grease
Silt Depth: (in.) Deposits Extent:
Infiltration: **None** Pipe Seal Cond: **Sound**

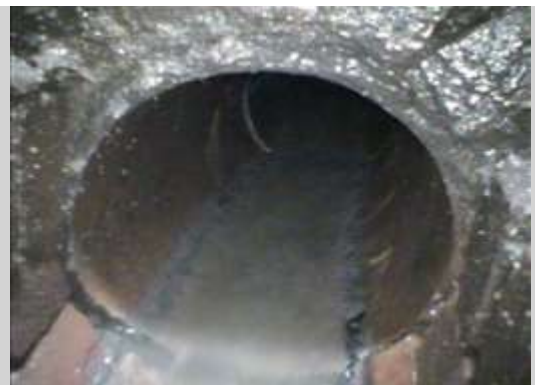
3 O'Clock Inflow

10 in. Circular Gravity Sewer
Pipe In @ 3 O'Clock

Pipe Height: **12** (in.) Rod and Bar (Angled)
Pipe Material: **Unknown** ☐ Pipe Lined
Invert Depth: **11.00** (ft.) Flow Characteristics: **Fast**
Deposits: ☒ None ☐ Mud ☐ Sludge ☐ Debris ☐ Grease
Silt Depth: (in.) Deposits Extent:
Infiltration: **None** Pipe Seal Cond: **Sound**
